# **Report on Arboricultural consultation visit & advice from Saul Health, ArborSense Arboricultural Consultants**

By Tree Warden, 25 March 2020

A two hour tour was held with the arboriculturalist on Friday 13 March 2020.

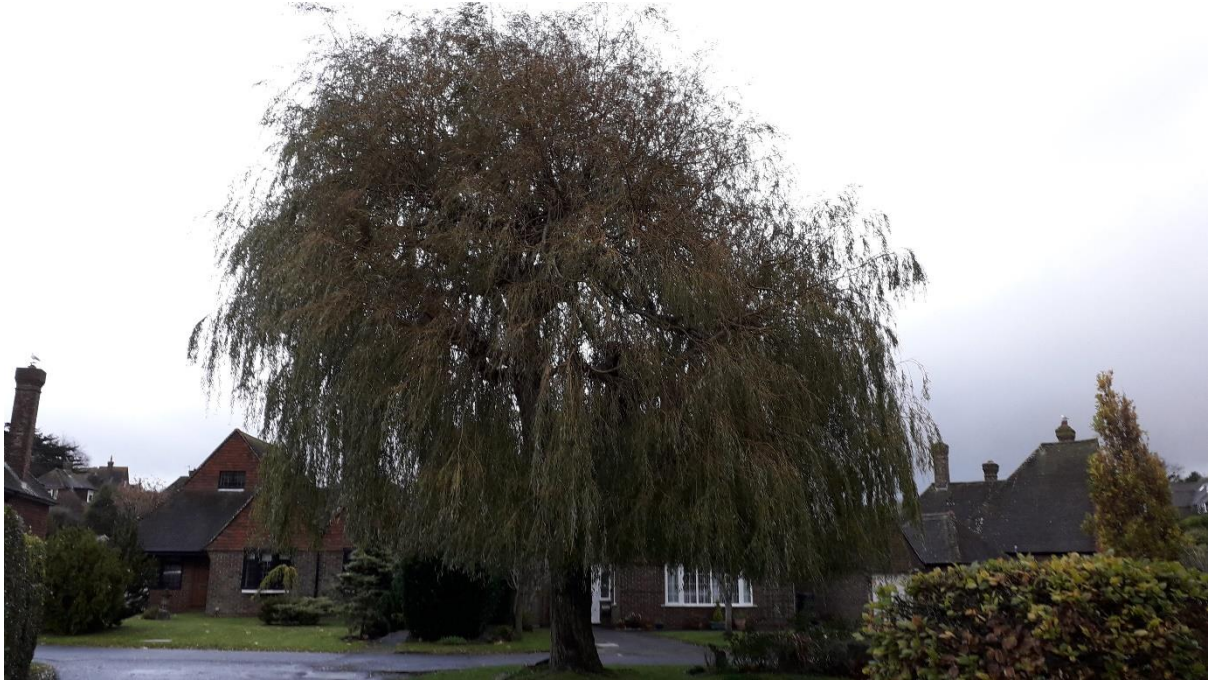
On the back of recent works on a TPO'd Willow – photos are appended (A1&2) - on the Downlands Estate in East Dean with a history of invading the nearby foul water drain, the tree warden has been investigating what evidence-based best practice is to prevent tree roots invading drains. Neither Forest Research (attached to Forestry England), the Arboricultural Association (without being a paid up member) nor the Arboricultural & Biodiversity Officer at WDC, were able to assist.

ArborSense advice is that *in this case, comparing the tree's age with when the house was built, the drainage system has been located too close to the tree. The owners of the drain should be responsible for its structural integrity and functionality, e.g. by inserting a protective sleeve to block up holes already made by roots and to stop new invasion. The works carried out on the tree will not prevent its roots invading the drain again.*

(A1) TPO'd Willow, 4 Went Hill Close – before works, 14 November 2019

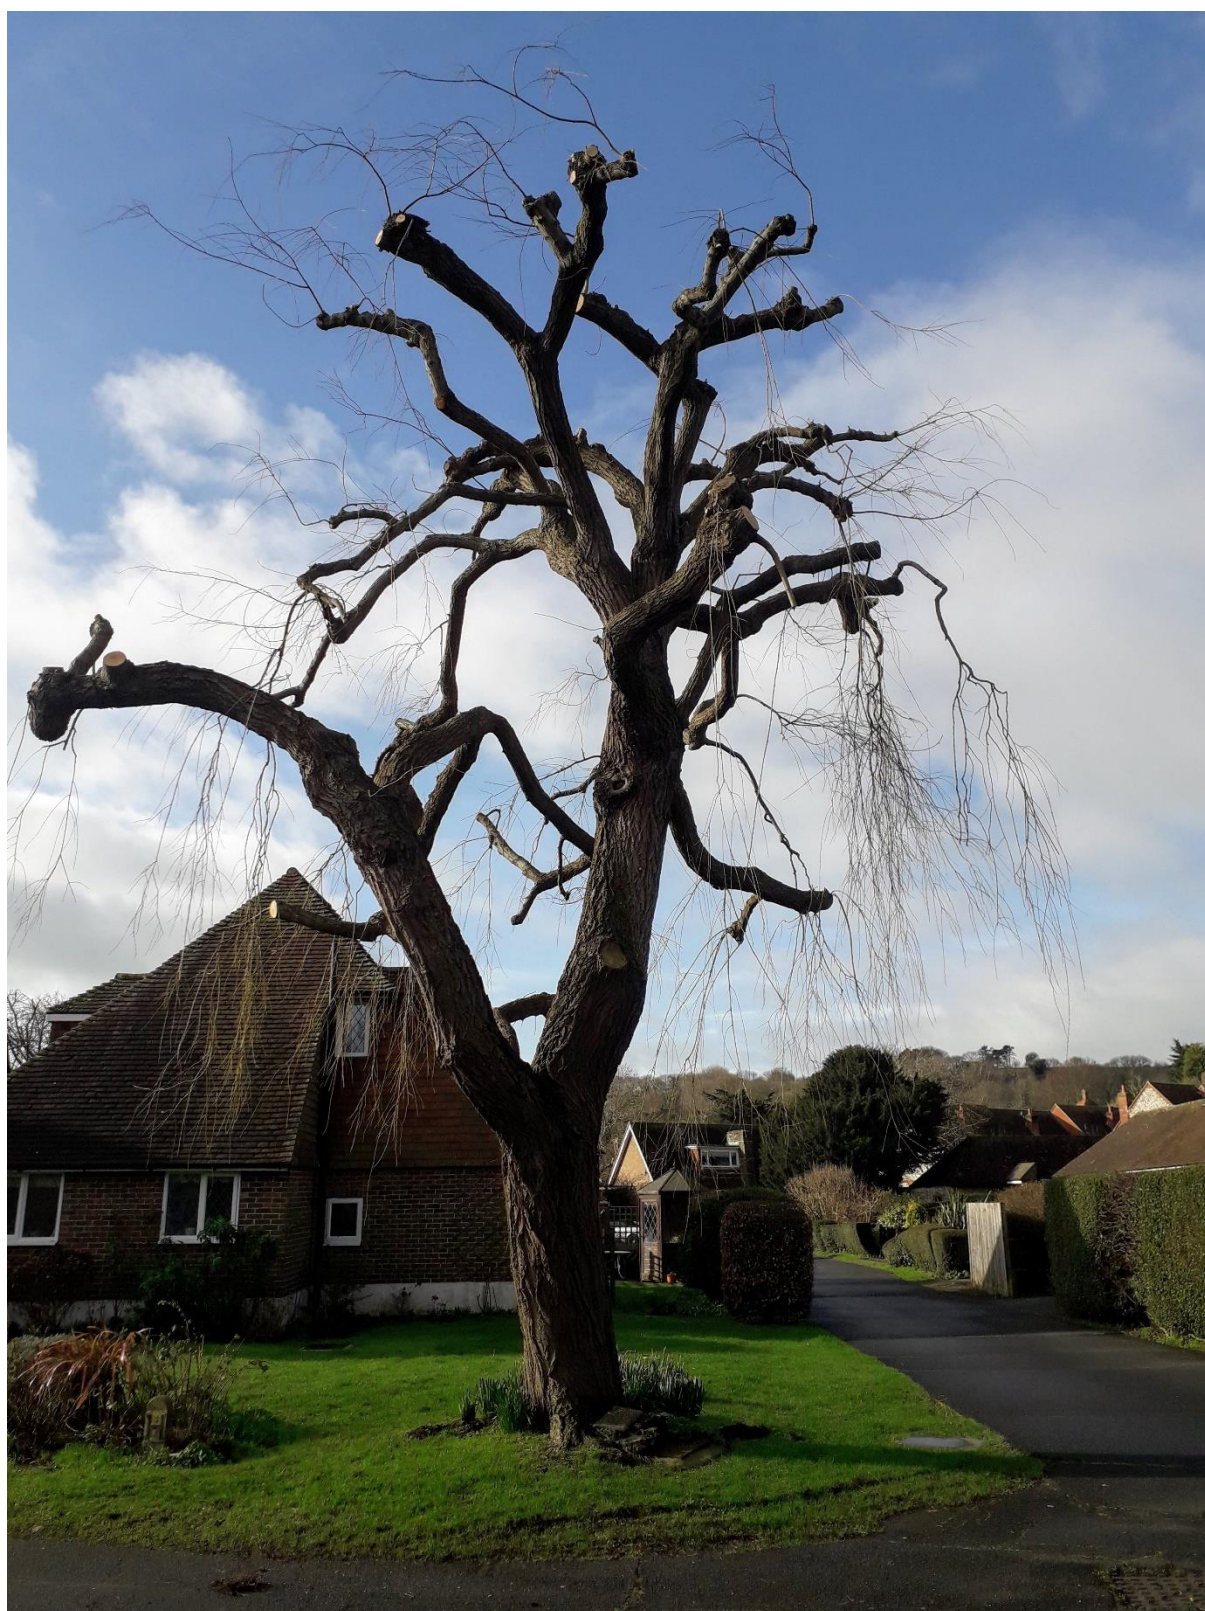
(A2) TPO'd Willow, 4 Went Hill Clse – after works, 14 February 2020

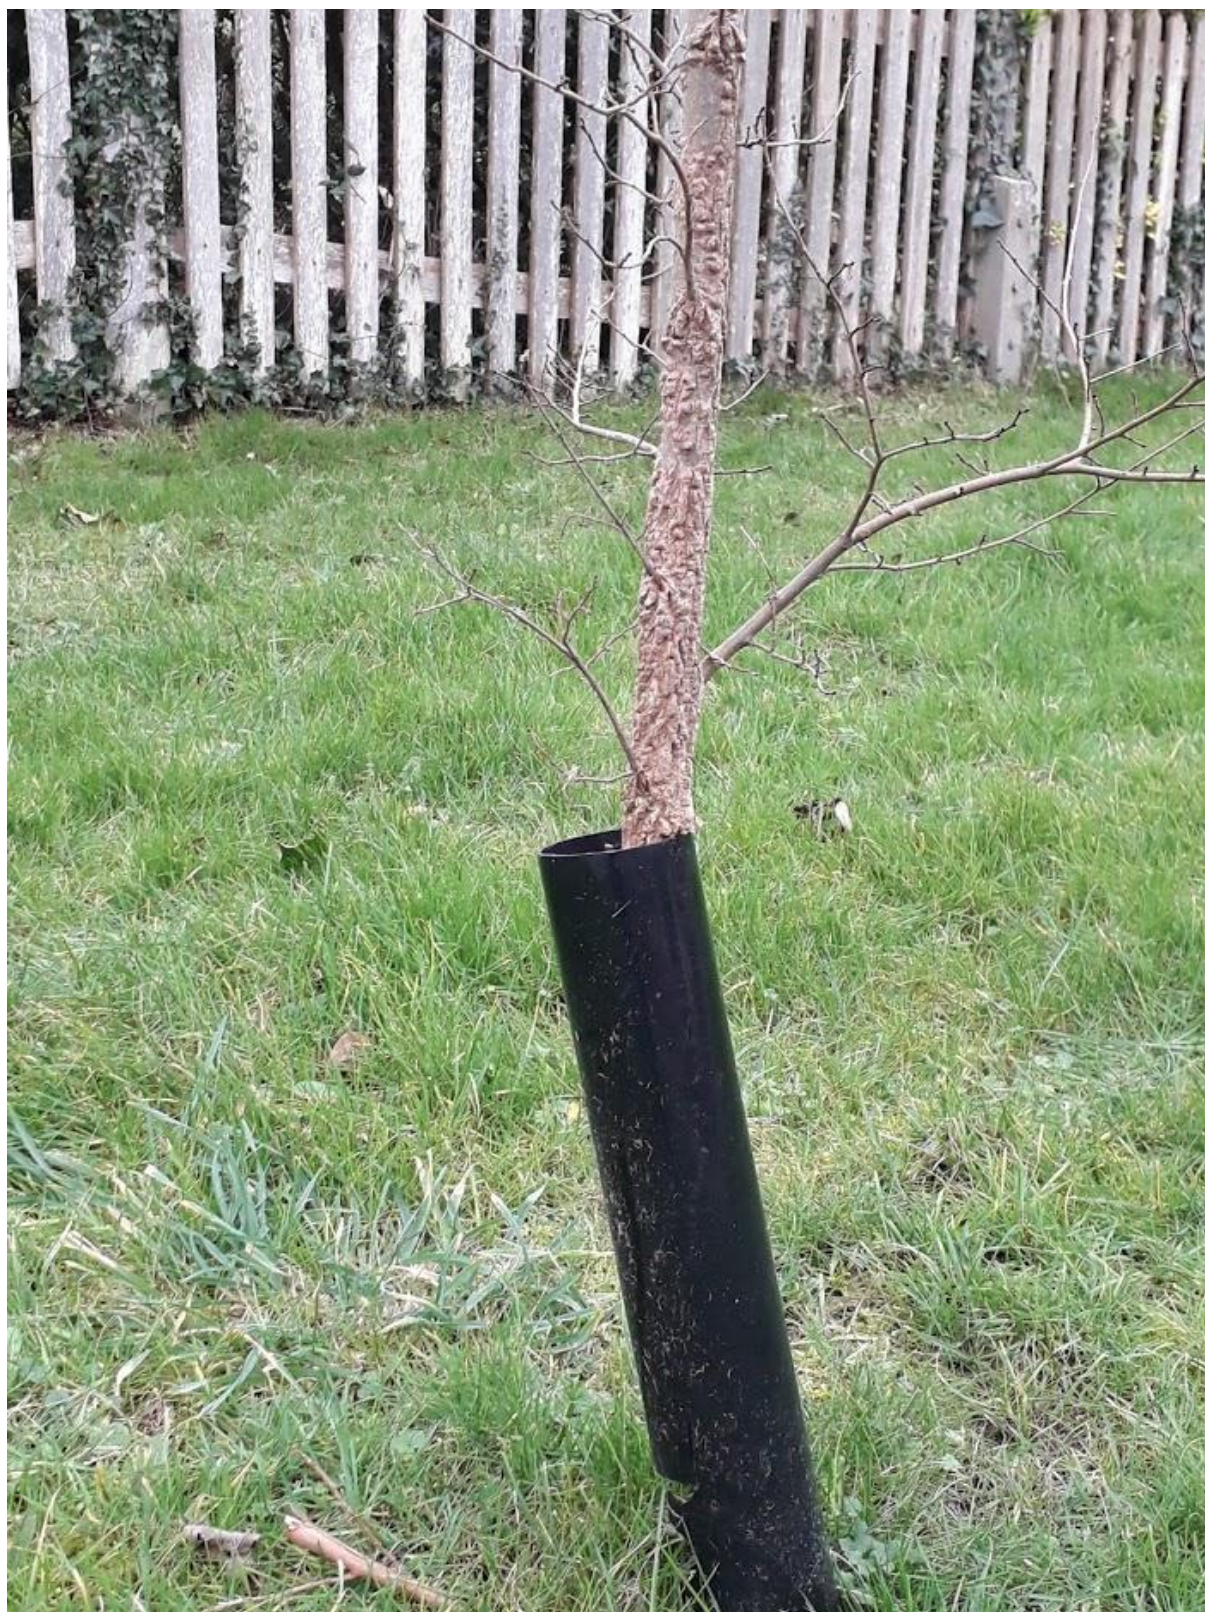
Further to a parishioner reporting their concerns about the condition of some of the young elms, sourced from the Conservation Foundation and planted by community volunteer/s some years ago now, the tree warden inspected them and reported to Councillor Hill that, at least, two specimens had been harmed by the trunk protectors still in situ - photo appended (B1).

(B1) Elm cultivars, Gilberts Drive – outside Churchfield with solid black plastic protector, 1 January 2020

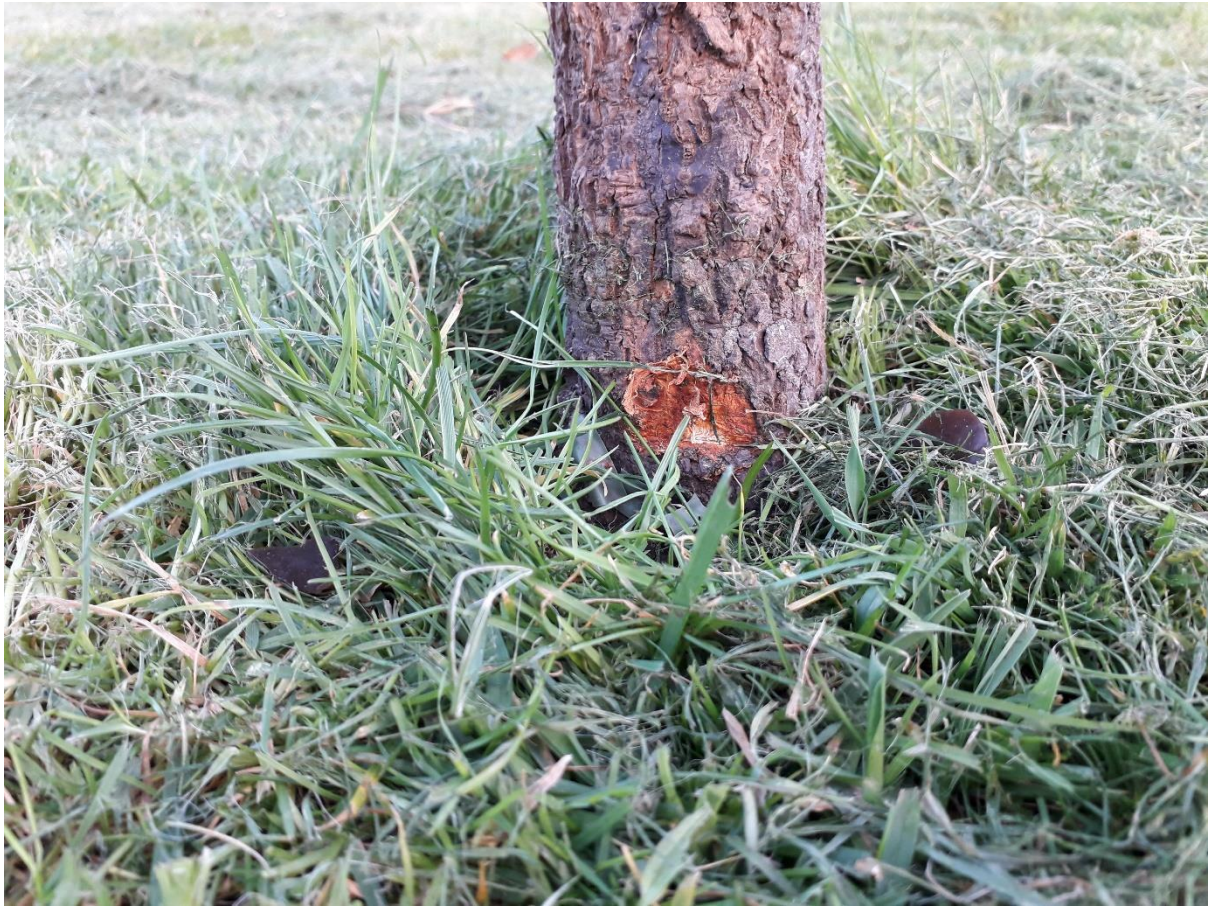
ArborSense advice, having removed the remaining protectors, now redundant, is that *strimming has clearly taken place too close to the trees causing visible damage. The trees*

are now established and should not require any further maintenance. Photos appended (B2&3).

(B2) Elm cultivars, Gilberts Drive – trunk protector removed revealing strimmer damage on day of mowing, 13 March 2020

As the first mow of the season was taking place on the day of the tour, the tree warden followed this up directly with the person in charge of the mowing contractors. ***The tree warden requests that the Parish Council revise the specification of its contract with the local contractor requiring that strimming does not get closer than 1 foot away from the tree trunks, as this will allow the grass within this protective circumference to grow longer.***

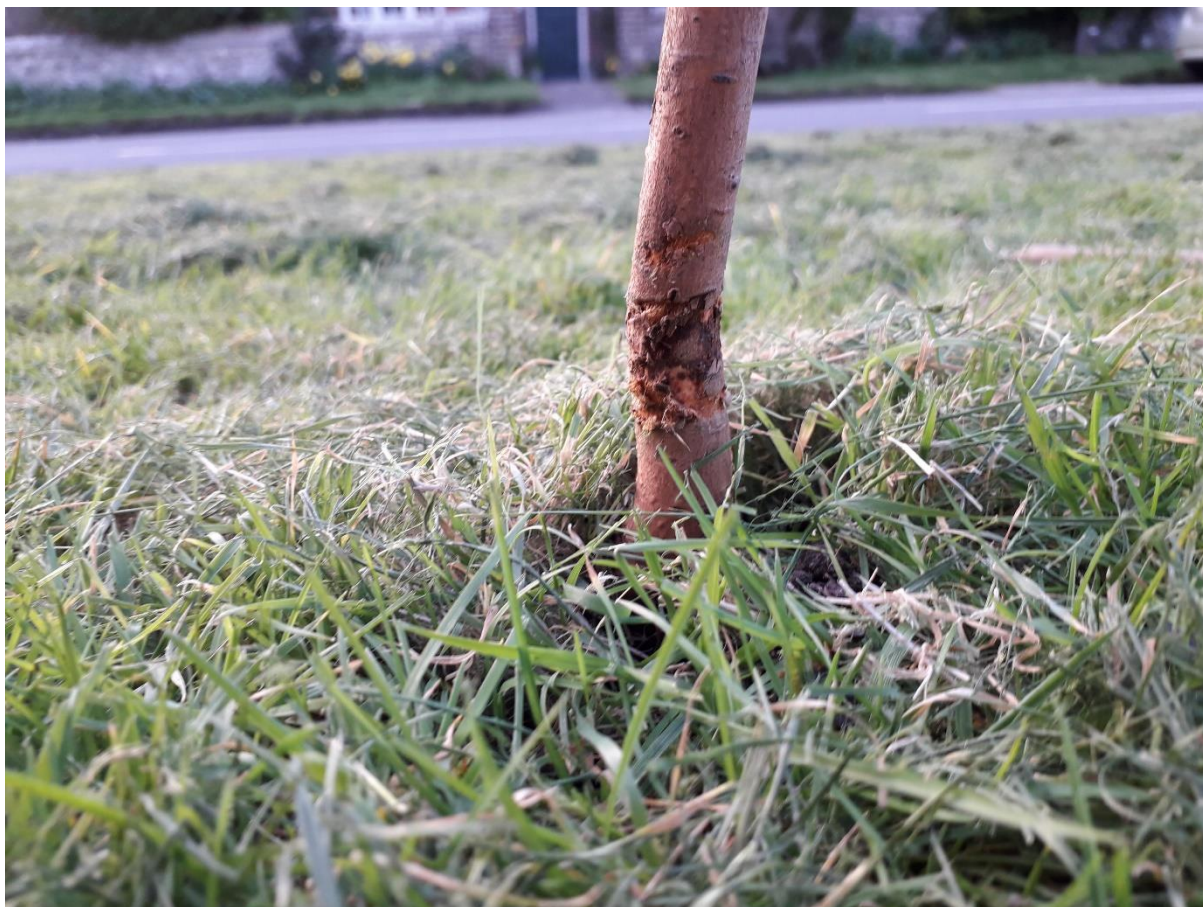
(B3) Elm cultivars, Gilberts Drive – trunk protector removed revealing strimmer damage on day of mowing, 13 March 2020

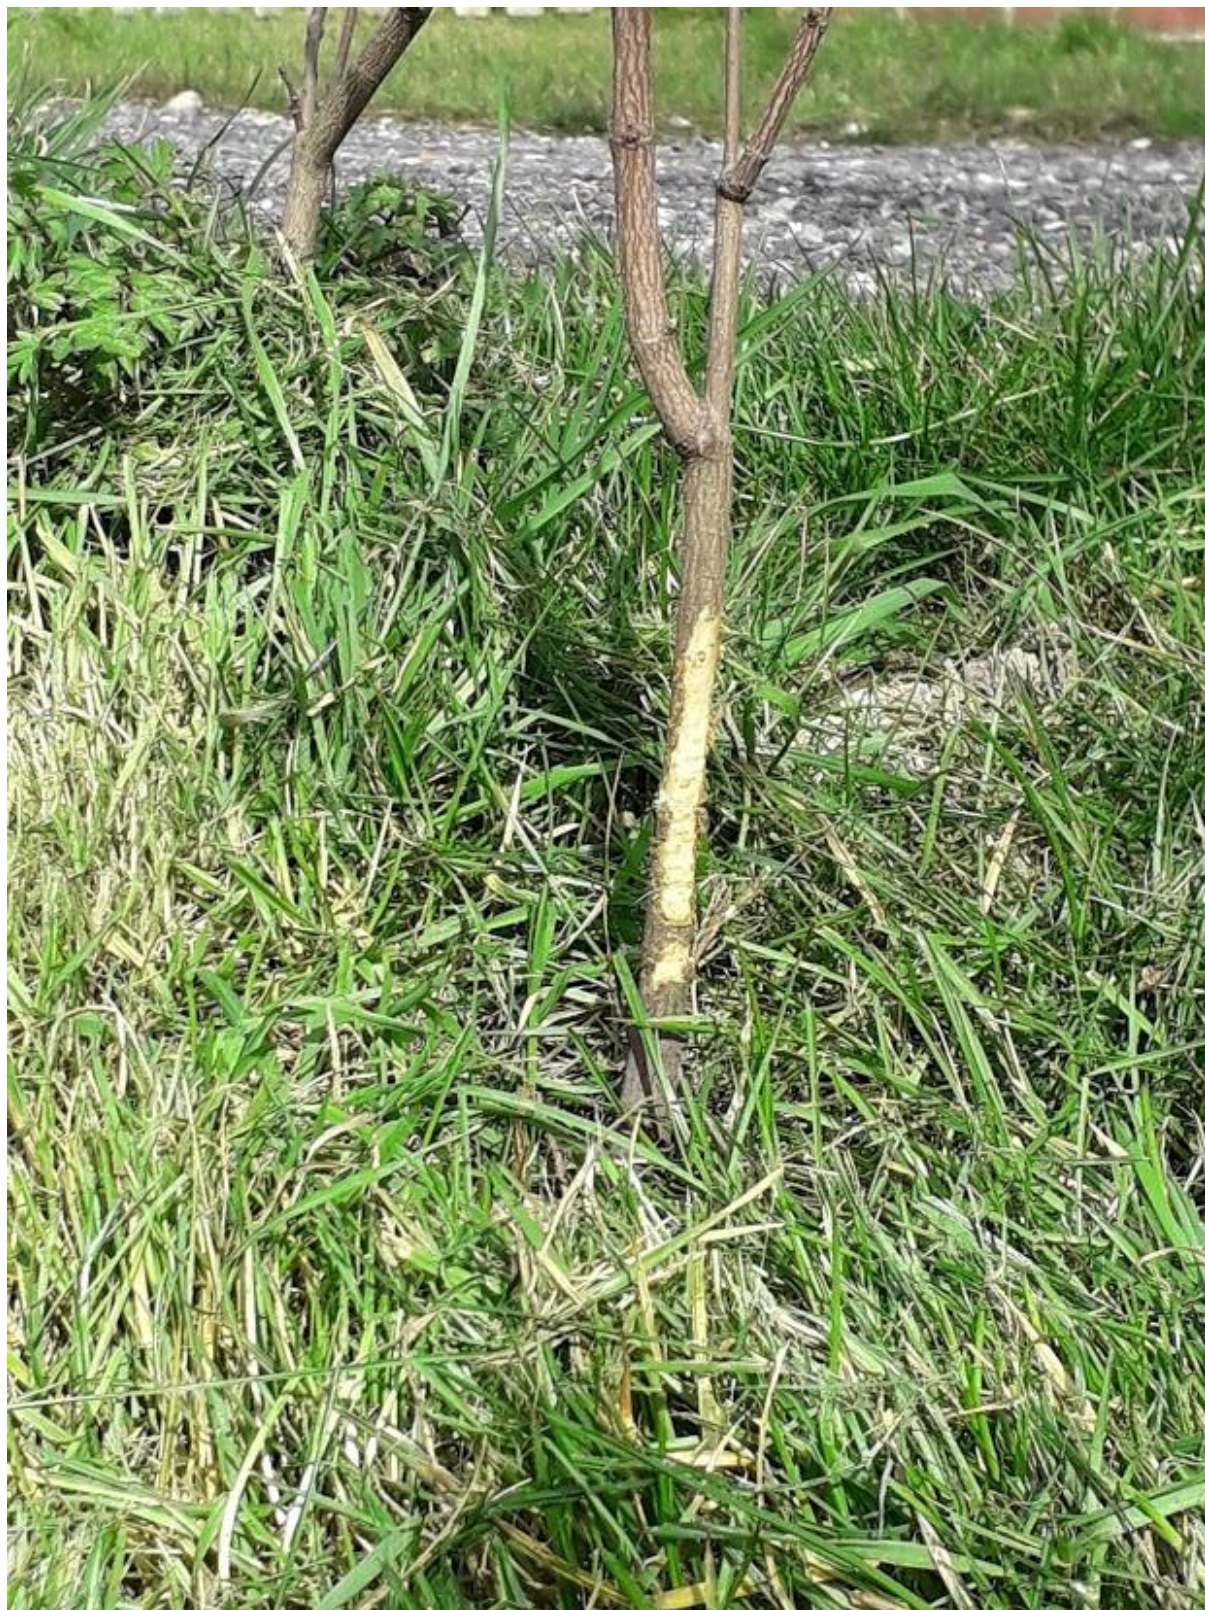
It was noted that the new landscape hedgerow planting against the build out on Gilberts Drive had also been damaged on the day by strimming too close to the young saplings, including to one that had been completely uprooted - photos appended (C1&2). ***The tree warden requests that the Parish Council revise the specification of its contract with the local contractor so that strimming is only carried out, in future, against the wooden bollards, thereby, leaving a protective 1ft deep grass border in between the bollards and the new hedge.*** The contractor will need reminding, though, as they mow the grass 10 times a season and often use casual labour. ***The tree warden, therefore, requests that the Parish Clerk put him in touch with the mowing contractor.***

(C1) New hedge planting by first mow of the season against new build-out, Gilberts Drive - strimmer damage on day of mowing, 13 March 2020

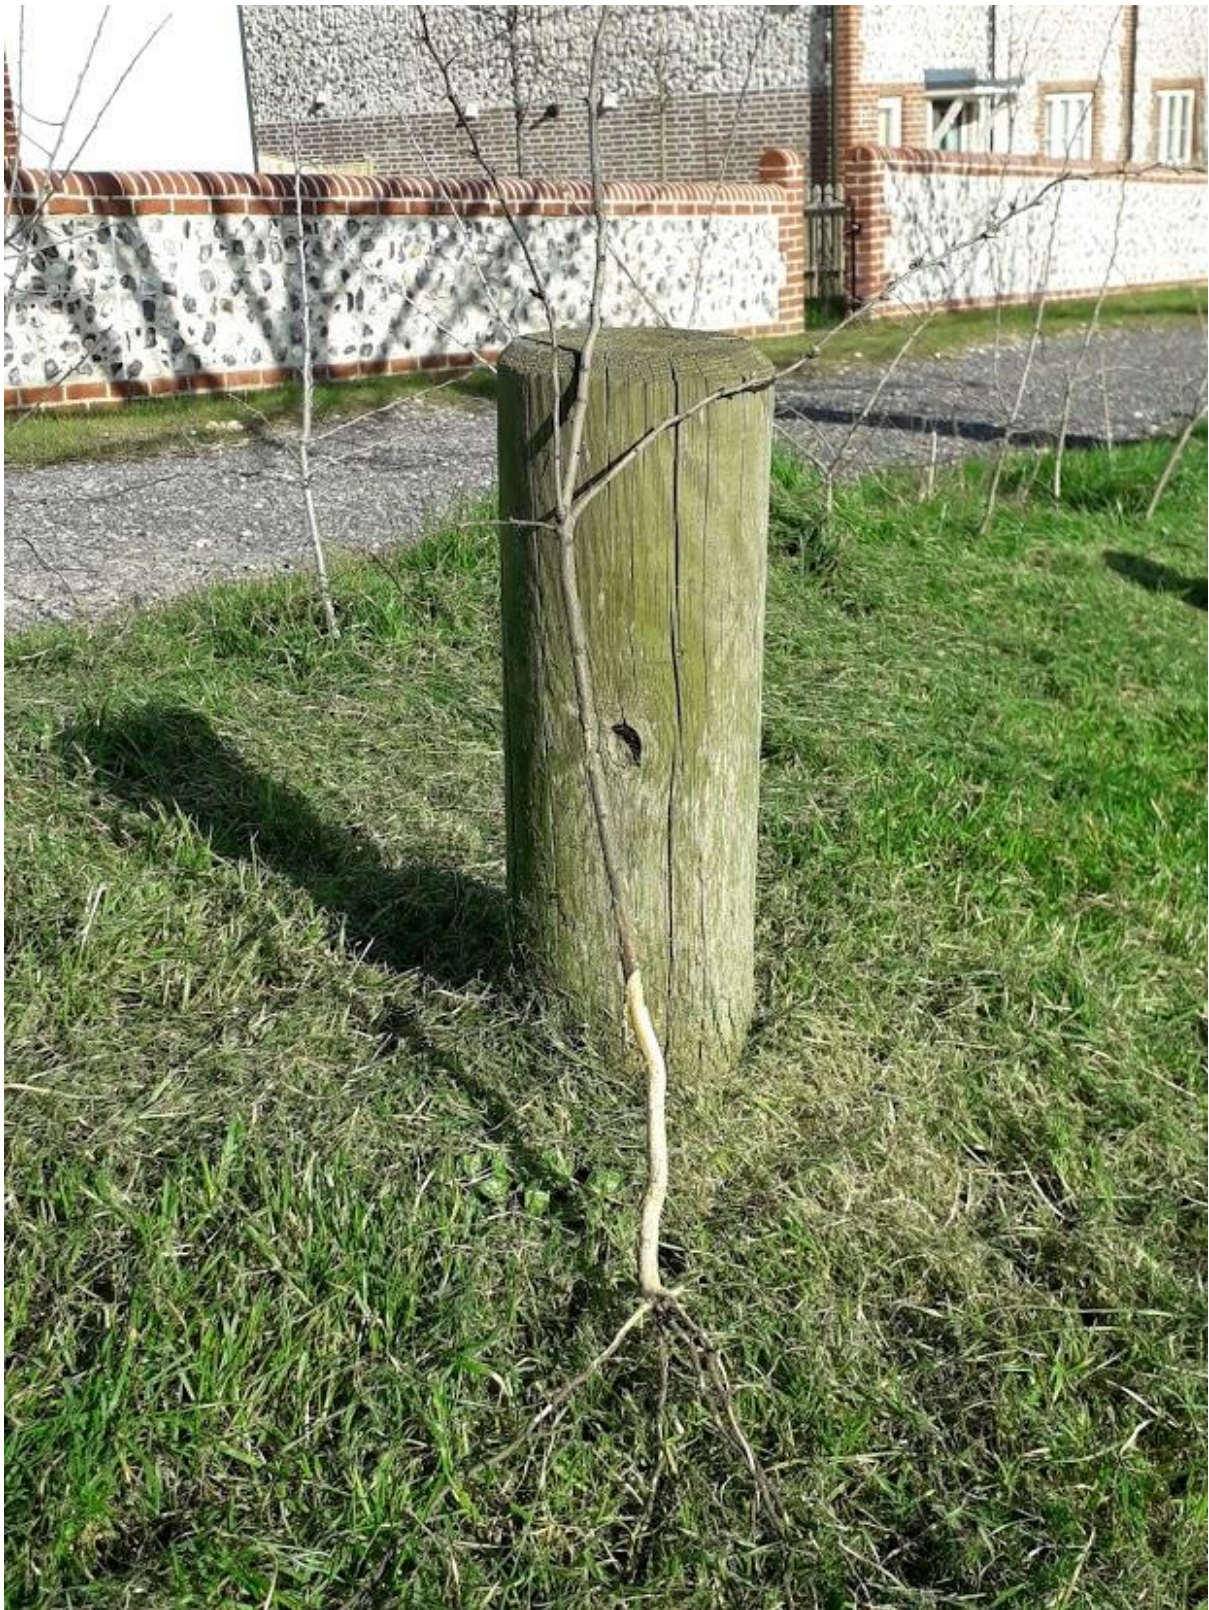
(C2) New hedge planting by first mow of the season against new build-out, Gilberts Drive - strimmer has uprooted sapling, 13 March 2020

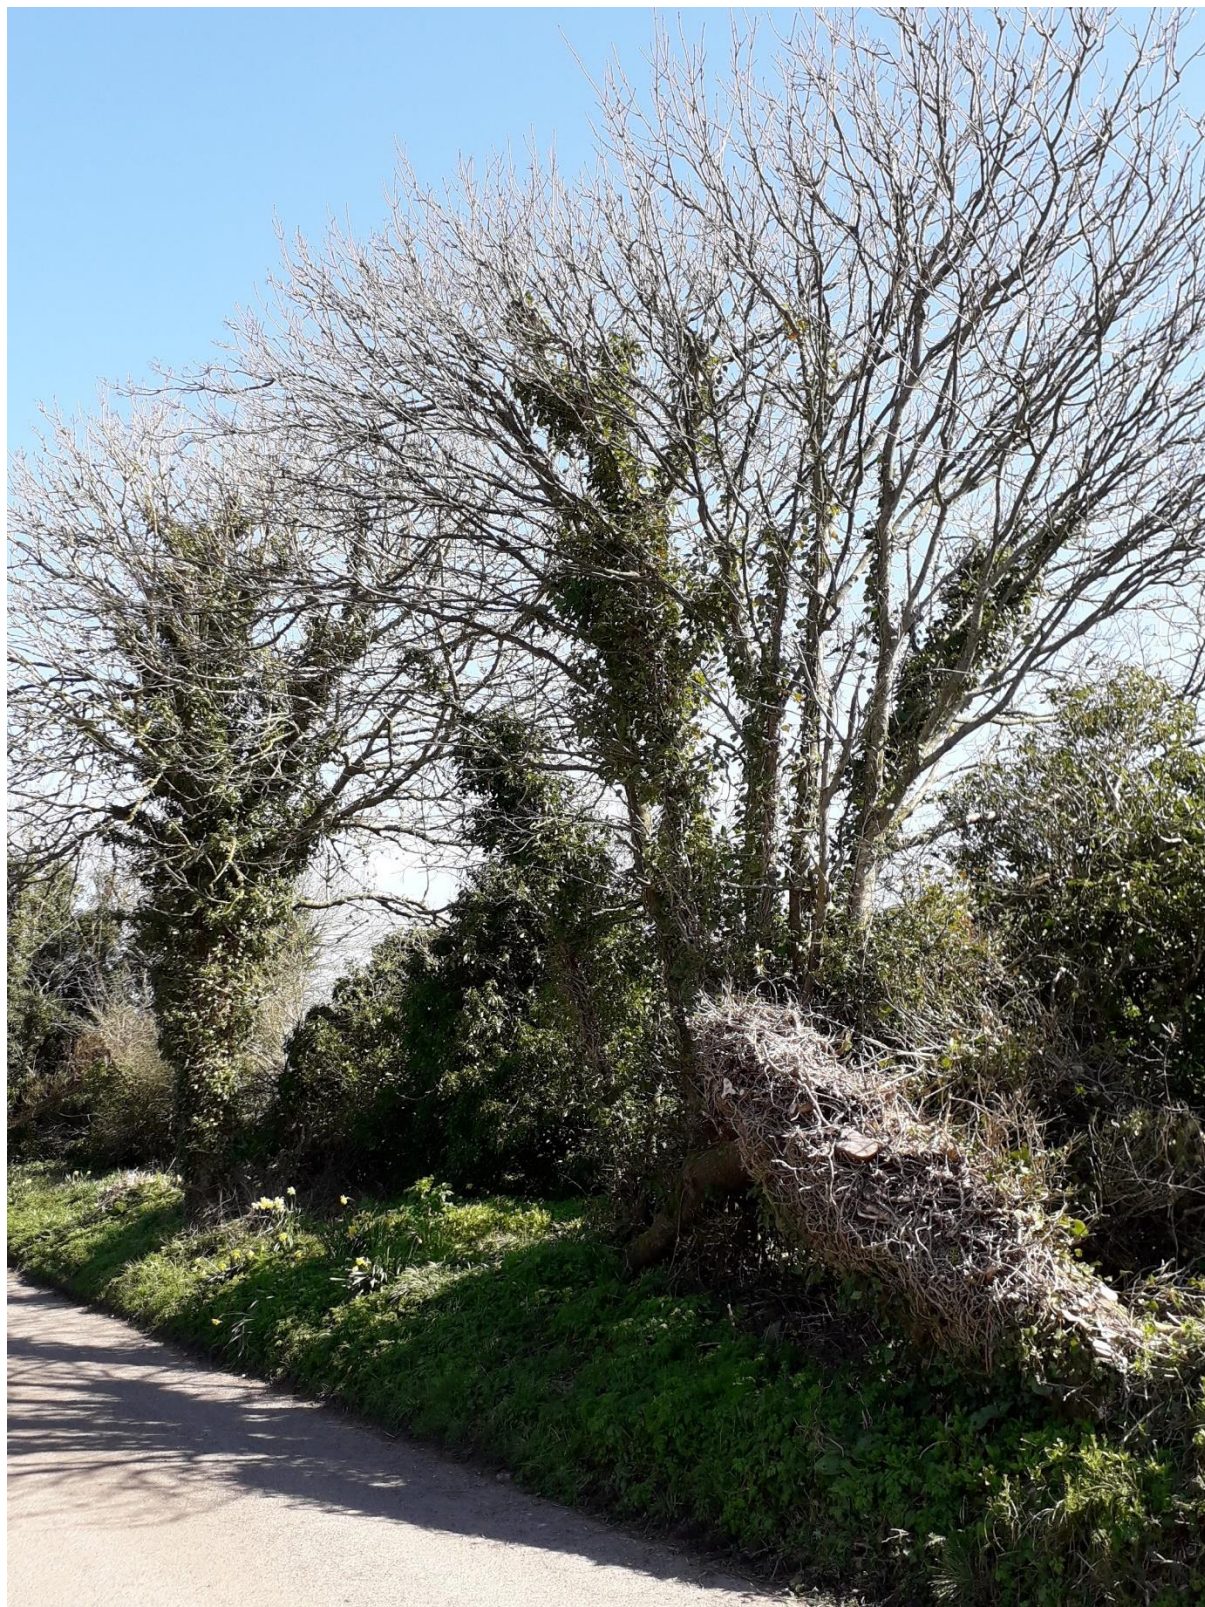
(D2) Ivy advised to be cut in November/December on beech trees, Downsview Lane, 24 March 2020

It was noted that a *healthy young beech tree had been too severely cut back by the recent deep mow* - photo appended (D1). *This would have been better avoided. It would be a good idea in November/December to remove ivy on the trunks, leaving a thumb's gap, of the more mature beech trees* - photo appended (D2) - *(not the hedgerow) towards the eastern end of Downsview Lane opposite the cul-de-sac road (footpath 21b): the ivy provides valuable habitat towards the end of summer in the hedgerow.*

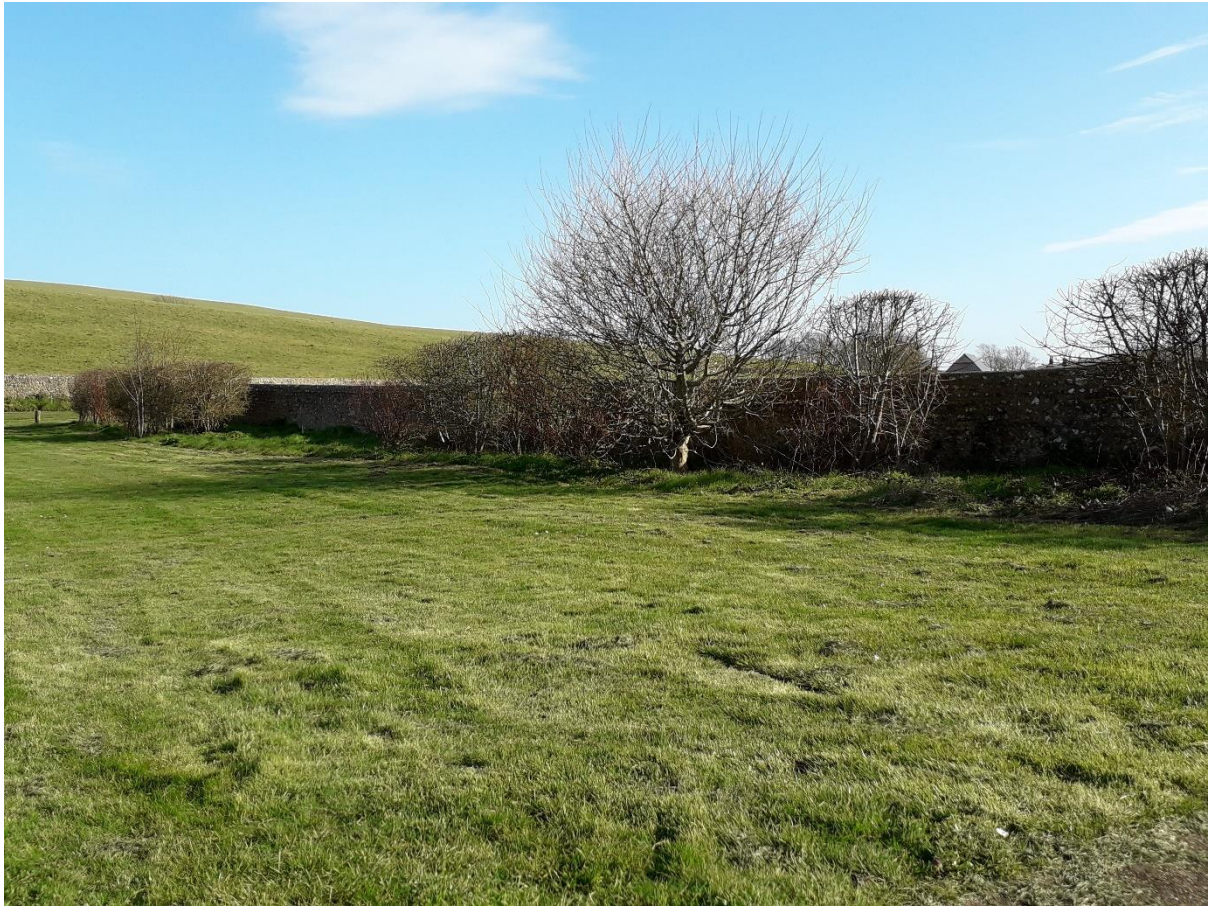
(E1) Gaps in Diversity Strip, Playground, one long, one short, to be replanted  
November/December 2020

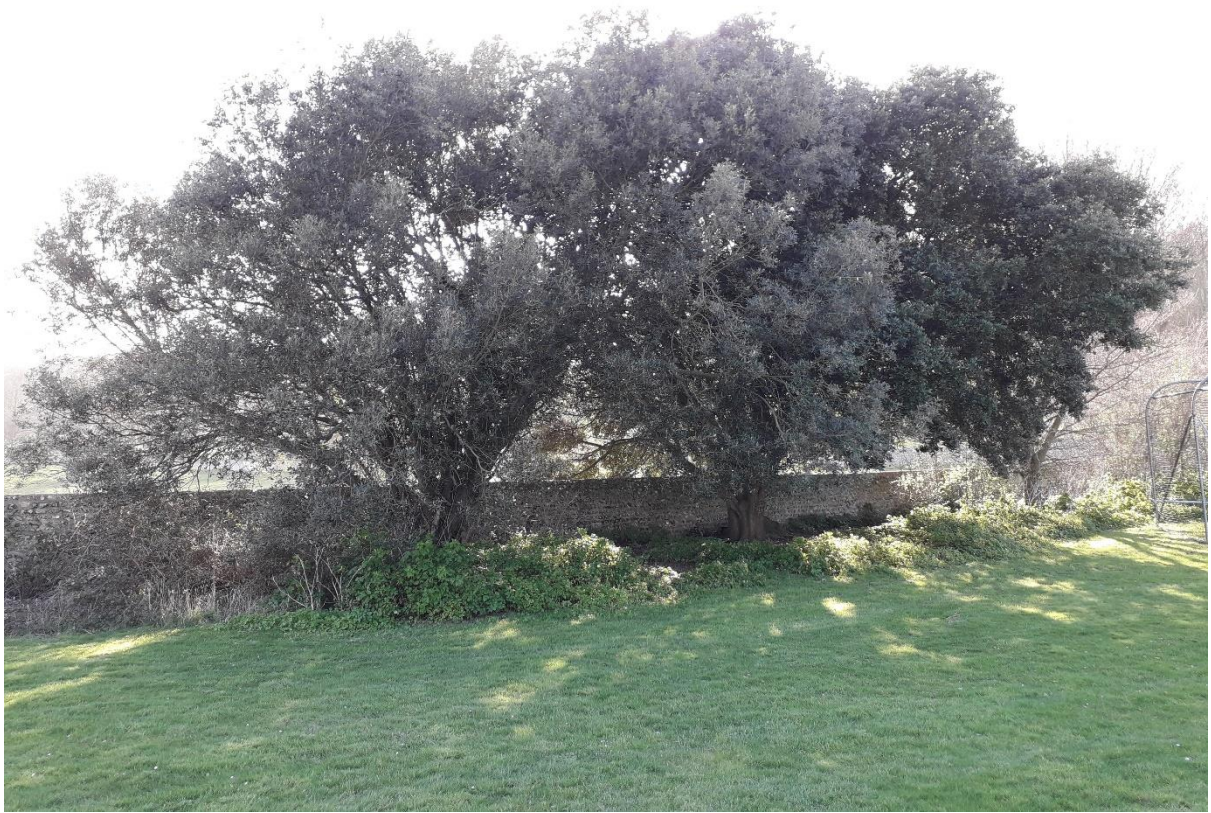
(E2) Two Holm Oaks in Diversity Strip, Playground, 13 March 2020

- *remove existing stake round one tree*
- *Holm oak nearest Gilberts Drive - photos appended (E2&3) - remove ivy on trunk, leaving a thumb's gap, wherever it's most comfortable to cut. Remove elder in front, first, for easier access*
- *cut bramble back annually from trees down to road.*

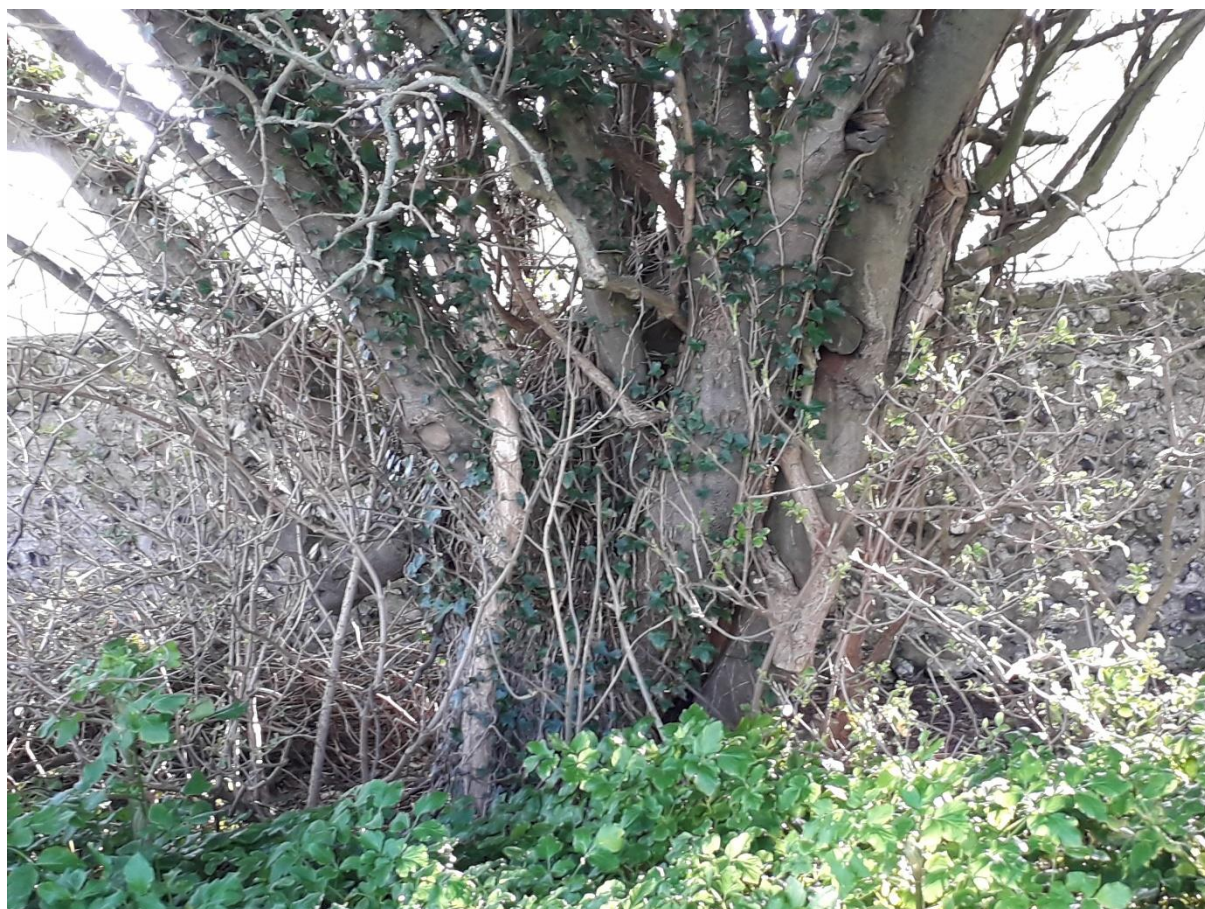
(E3) Holm Oak in Diversity Strip, Playground, with ivy overloading it, to be cut back  
November/December 2020 – 13 March 2020

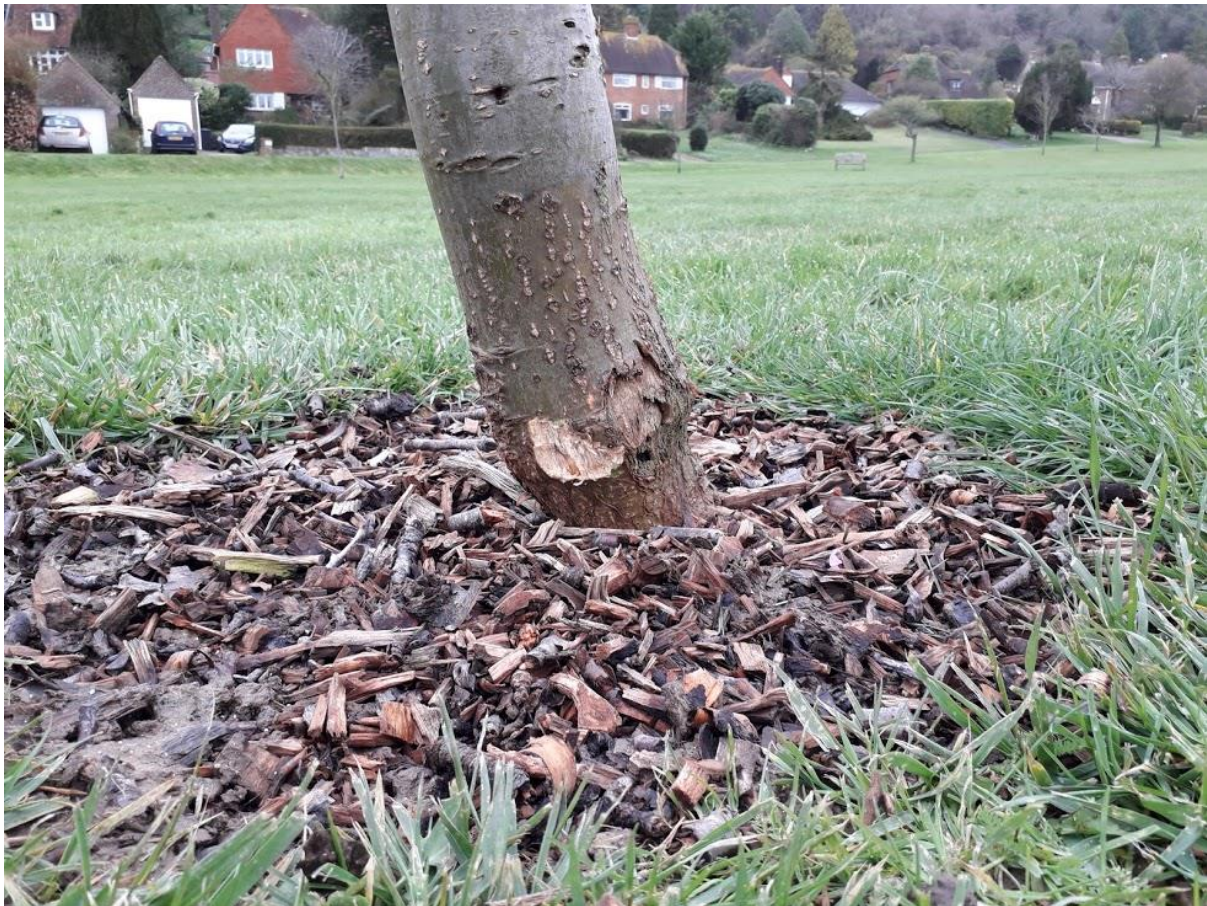
On inspecting the young trees that the EDFRA had paid to be protected from the contracted mowing at the end of last summer, the tree warden found further damage to some trunks on the first day of the mowing season - photo appended (F). ***The tree warden requests that that the Parish Council reiterate the previously amended specification of this contract in order to avoid ongoing damage.***

(F) Continuing mowing damage on the Greensward to the trunks of young trees that had, in Summer 2019, been protected from strimming by a bark chip border – 14 March 2020
