**Title:** Report Item 13(f) – State of the Tennis Net

**Purpose:** To provide a condition report as requested on 3<sup>rd</sup> June 2021

### **Tennis Net at East Dean**

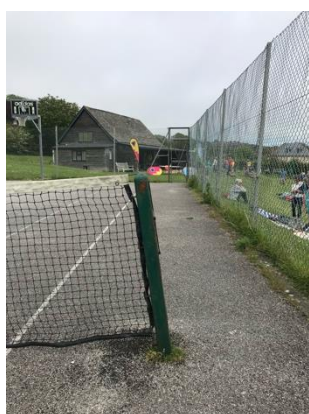
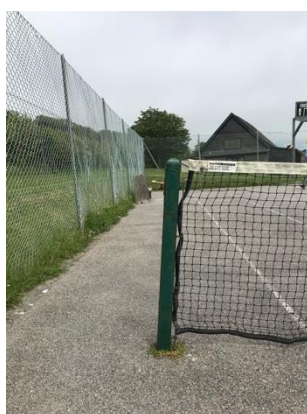
The net posts are leaning in towards the centre of the court. (Pic 1 and Pic 2)

This may be something to do with how the net posts are installed but without digging around the base of the net posts it is hard to tell. It is most likely happening because the net is being left under tension when not in use. It would be useful to have a sign reminding parishioners that they should de-tension the net using the winding mechanism (pic 3), as this will go some way towards preventing this issue worsening.

In an ideal world, the net posts would be re-conditioned in some way and re-set, but I am not sure it would be worth the potential expense at this stage, as this could be factored in to any future plans to resurface the court.

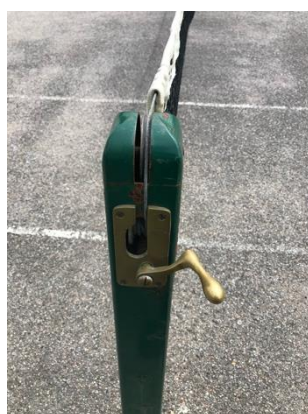
Pic 3.

The winding mechanism is in good working order. The net posts are rusted (pic 4) and don't look that nice but there is nothing wrong with them that will stop them from functioning.

As the winding mechanism is in good working order, it would be useful to have a net measure available for people who want the net to be the right height. This would be 3ft at the centre of the net. It could literally be a piece of wood cut to 3ft so no major expense.
